# RECON NEWS

## BOLT AND OTHER THREAD FAILURES

**A LONG WINDING THREAD FAILURE YARN**

**THE MANUFACTURING DEFECT**

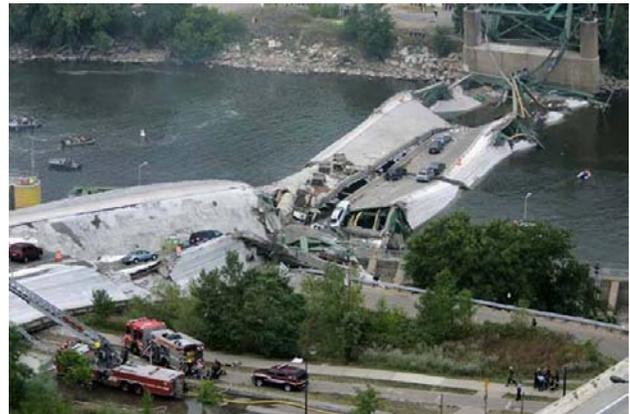
Mechanical failures come in all shapes and sizes. Since this bridge survived for 30+ years, it is obvious to us that its strength degraded substantially before the failure occurred.

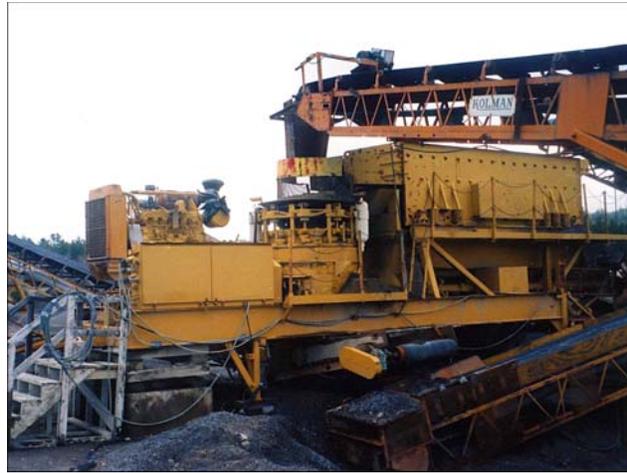
It all started when a high-pressure pipe connection in a large rock crushing machine failed, causing a length of pipe to swing out and seriously injure a worker standing nearby (Exhibit 1).

*Exhibit 1 – The rock crusher.*

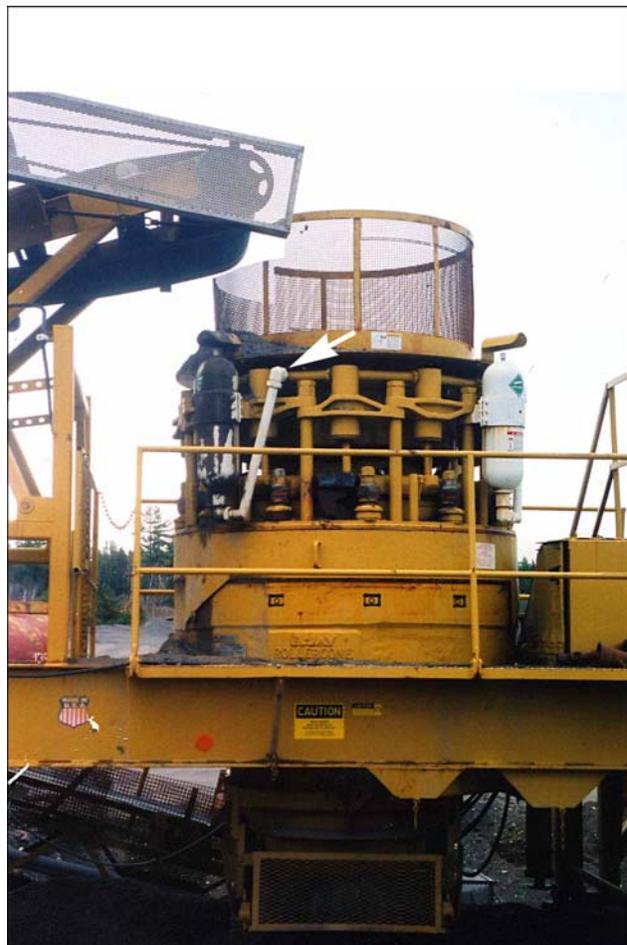
*Closeup of the area of failure.*

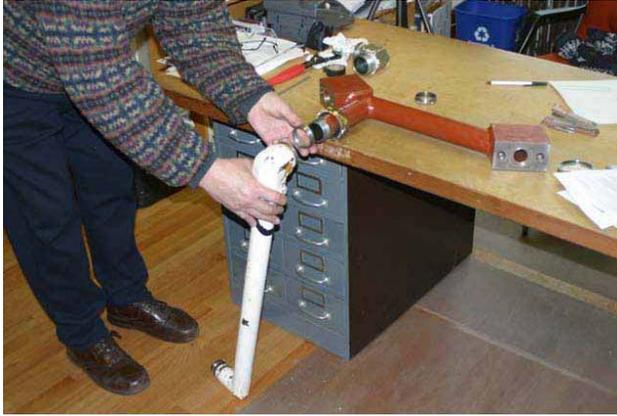
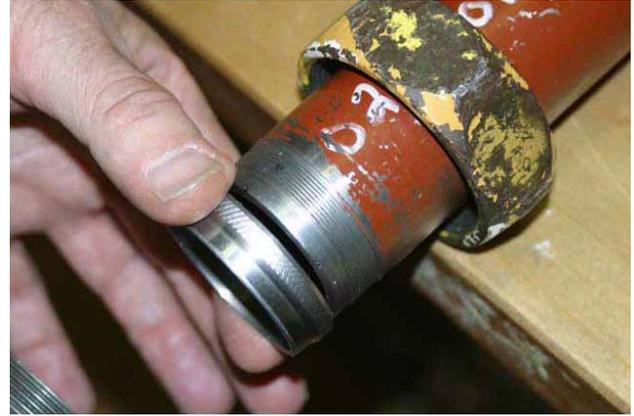
*Exhibit 2 – Supply pipe and manifold assembly.*

Exhibit 2 shows the supply pipe, the manifold section to which its top elbow was attached, and the method of attachment. A ferrule or collar was threaded onto the end of the manifold pipe to provide a stop for the large threaded nut used to secure the supply pipe to the manifold pipe. When this connection failed, the ferrule pulled off the manifold, and the supply pipe rotated forward.

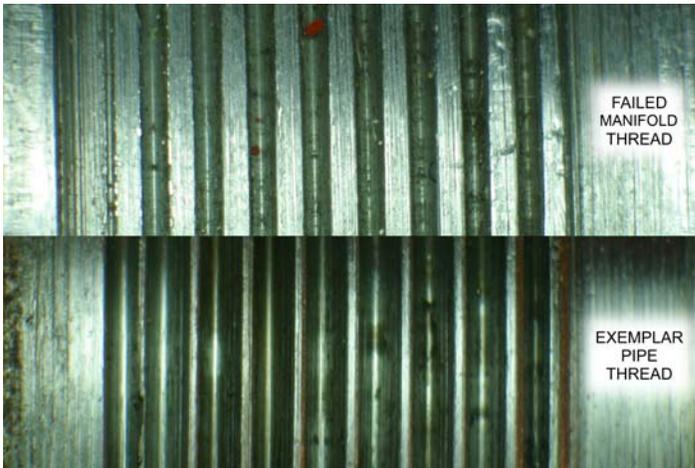
*Exhibit 3 – The threads viewed top down.*

We studied this failure by comparing the failed connection with an identical connection at the bottom of the supply pipe that did not fail. Exhibit 3 shows two edge-on photos comparing the failed manifold pipe threads with the pipe threads at the bottom end of the supply pipe. Exhibit 4 shows two side-on photos comparing these same threads.

It was obvious to us that the tops of the new manifold pipe's threads were *not* sheared off as the ferrule came off the manifold pipe. The manifold pipe threads showed no plowing along their axis; they were sharp edged, and circumferential machining marks were still visible on their tops. Exhibit 5 shows that during manufacture the diameters of both pipe ends were reduced before they were threaded to accept the ferrules, but that much more metal was cut away from the surface of the new manifold pipe. We hypothesized that the ferrule pulled off the new manifold pipe because it had much less thread to grab.

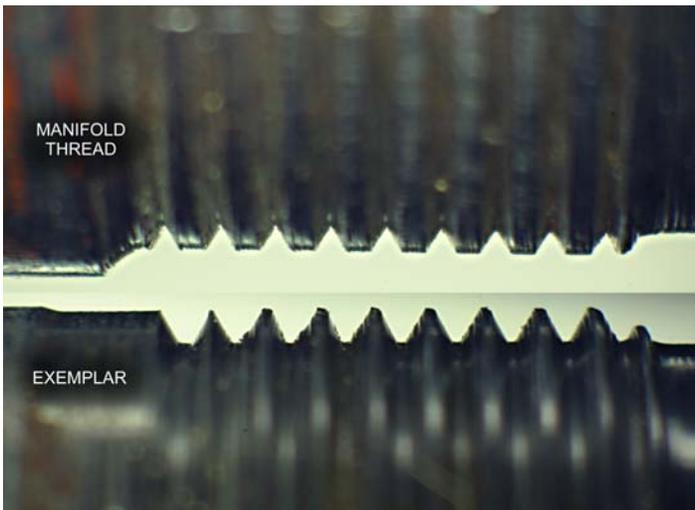
*Exhibit 4 – The threads viewed in profile.*

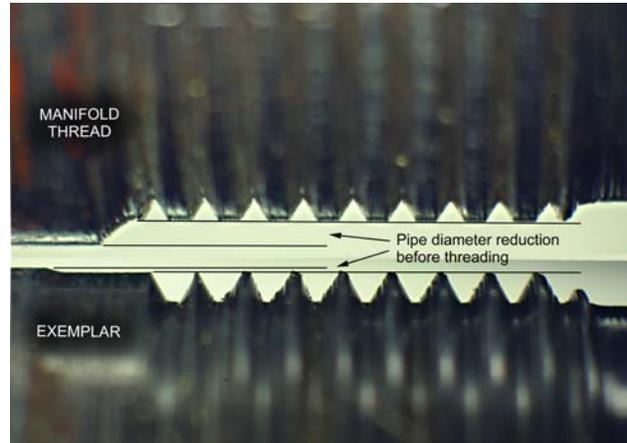
We checked our hypothesis by calculating the strength of the failed connection using the same equations we had developed for the B-CALC model in the 1980's, in which the pressure force pulling the connection apart was just balanced at failure by the shear force bulldozing the ferrule threads. With only about 29% of the ferrule threads damaged, the calculated failure pressure was almost exactly 2,500 psi.

Therefore, we were certain this accident happened because the new manifold section was incorrectly made. Too much of the metal near the end of the manifold pipe had been removed to reduce its outside diameter before the pipe was threaded to receive the ferrule. The resulting pipe threads were truncated. This error created the situation where the manifold's pipe threads met the ferrule threads near their tips where they were weaker. The pipe threads bulldozed through the ferrule threads, allowing the ferrule to slide off and let go.

*Exhibit 5 – The manifold pipe was turned down too much before threading for the ferrule.*

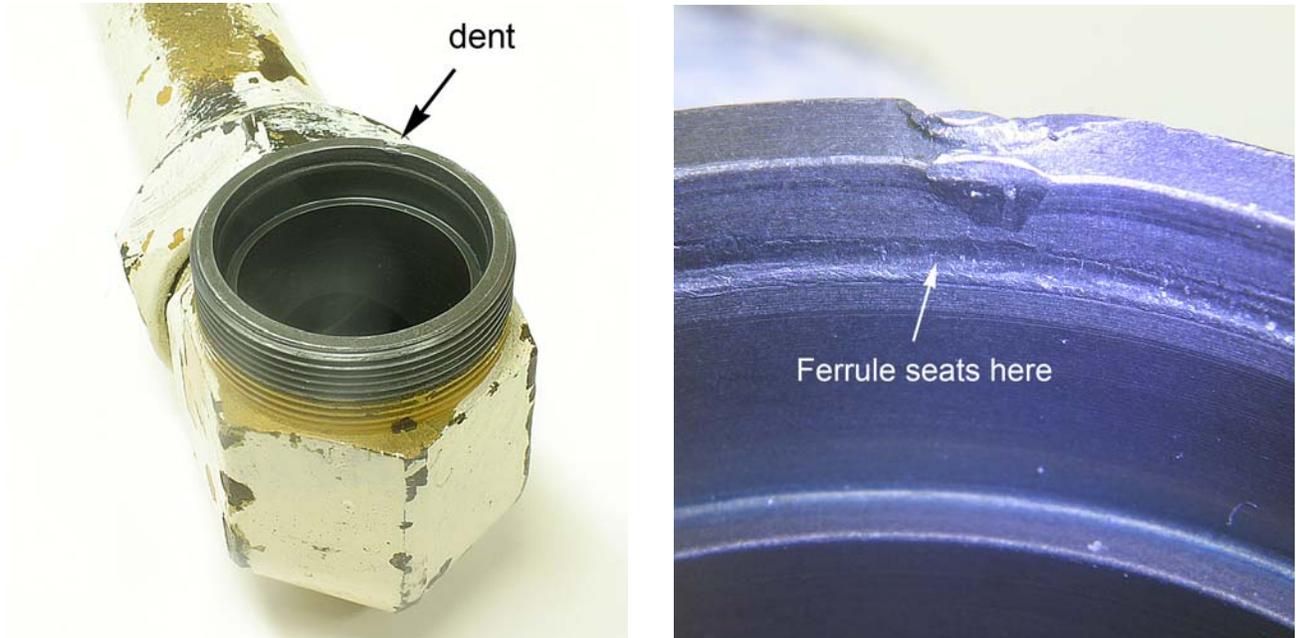
An engineer employee of the manufacturer focused on a small dent in the elbow at the top of the supply pipe (See Exhibit 6), saying that this dent, post manufacture, prevented the nut from tightening fully against the ferrule and allowed hydraulic oil to escape and pressurize the annular cavity of the sealing nut (See Exhibit 7), increasing the force pulling the joint apart and causing it to fail. He provided no evidence that hydraulic oil had entered this annulus, and no calculations to support his position. And he refused to acknowledge that the flattened threads were a manufacturing defect, even though the marks on the tops of the threads were circumferential, not axial.

We used the evidence to refute his position. We produced photos like Exhibit 6, clearly showing that the seal between the ferrule and the elbow was not affected by the dent.

Exhibit 6 – The dent in the elbow and seating area.

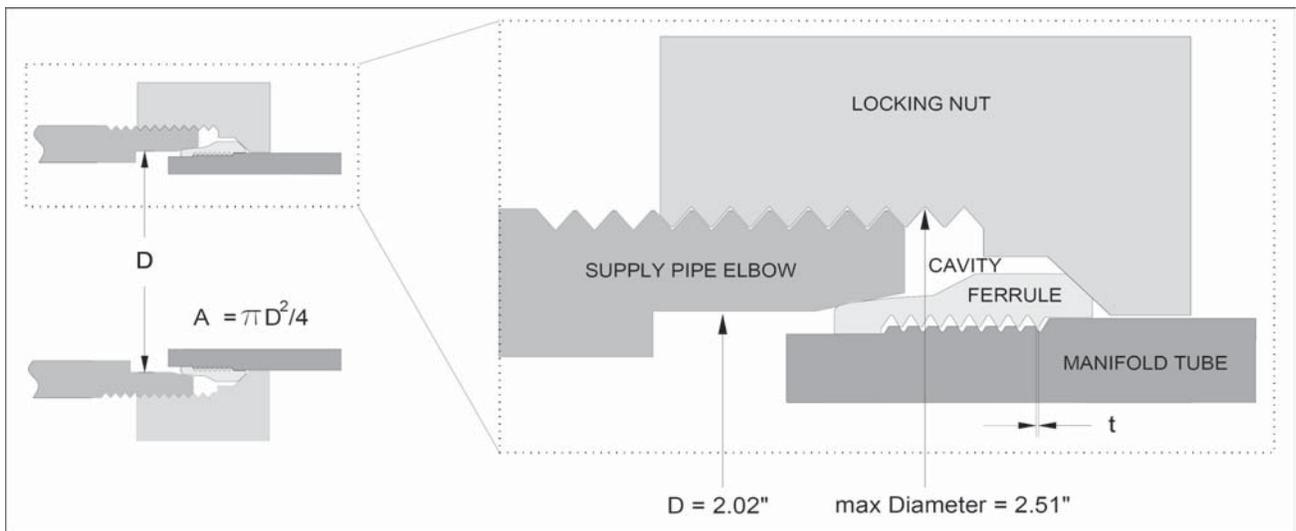
And we used the elbow geometry in Exhibit 7 to refute his position. If hydraulic oil did leak into

this annulus, the greatest additional axial force it could create was the ratio of the increased areas since force is the product of pressure and cross-sectional area. The maximum diameter of the annulus was 2.51 inches; the inside diameter of the elbow 2.02 inches. Therefore, the maximum fractional increase in axial force due to such a leak was the square of the diameter ratio:

$$\begin{aligned} \text{Fractional axial force increase} &= [\text{cavity maximum diameter} / \text{elbow diameter}]^2 \\ &= [2.51 \text{ inches} / 2.02 \text{ inches}]^2 = 1.54 \end{aligned}$$

which is a 54% increase. But industry codes and the 8,500 psi calculation above showed that this hydraulic system was designed with a 4-fold safety factor. Therefore, there was no way that a 54% increase in internal axial force would make the system fail.

Exhibit 7 – Scale drawing of the threaded joint.

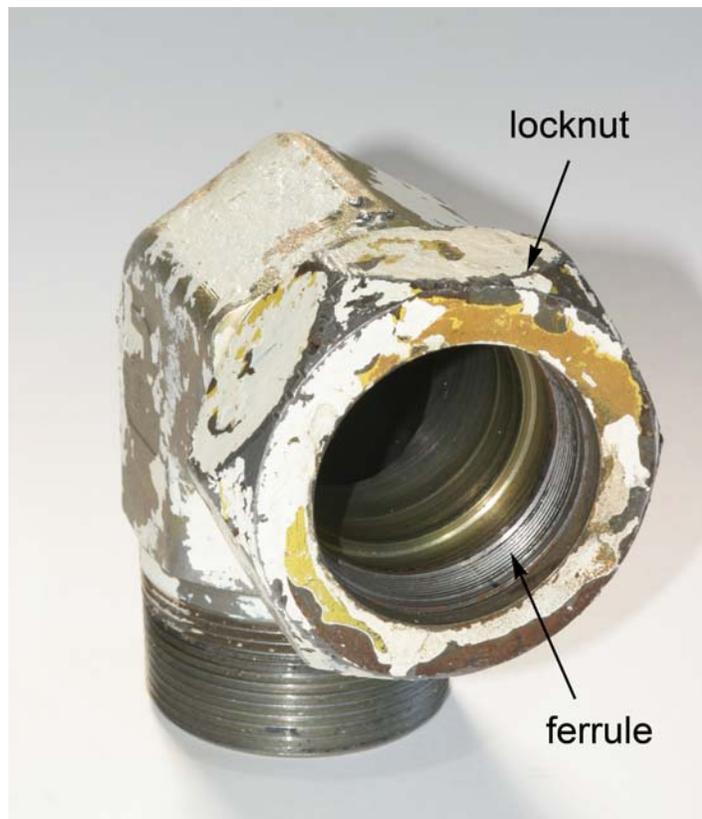
A PhD engineer hired as an expert witness by the defense also focused on the dent in the elbow, but he came up with an entirely different theory. He said the dent distorted the ferrule, allowing it to slip over the manifold pipe threads and make the joint fail. We placed the ferrule in the elbow without the manifold pipe and tightened the lock nut over it (See Exhibit 9), then measured the inside diameter of the ferrule at many places and found no distortion; the ferrule actually shrank. Therefore, the ferrule would have gripped the pipe threads even more tightly as the elbow nut was tightened, not slipped over them as this engineer had opined.

This engineer also suggested that the ferrule could dilate due to the forces generated by the ramping of its threads as axial forces generated by internal pressure pulled the joint apart. But reference to the literature shows that the dilation he spoke of is only valid for unconstrained nuts. In this case, the ferrule was constrained by the extremely thick backing nut (See Exhibits 6 & 9).

Exhibit 9 – The ferrule installed in the elbow.
